Title 1: A/C Compressor Just Quits For No Discernible Reason!

Title 2: Sometimes You Can't Worry "Why" It Failed; You Just Gotta Make It Work For The Customer!

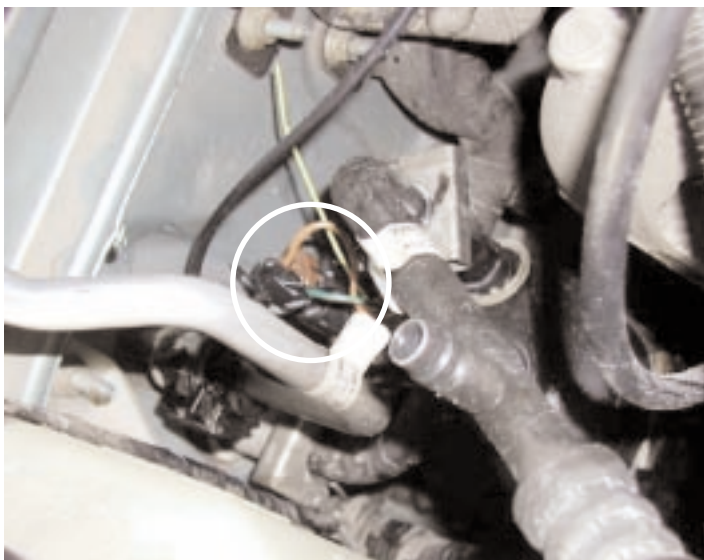
Above: Photo 1. In a 1997 Ford Escort, the PCS (low pressure safety switch), circled, is located in the engine compartment on the right-hand side of the firewall. The bypass wire has already been attached in this photo.

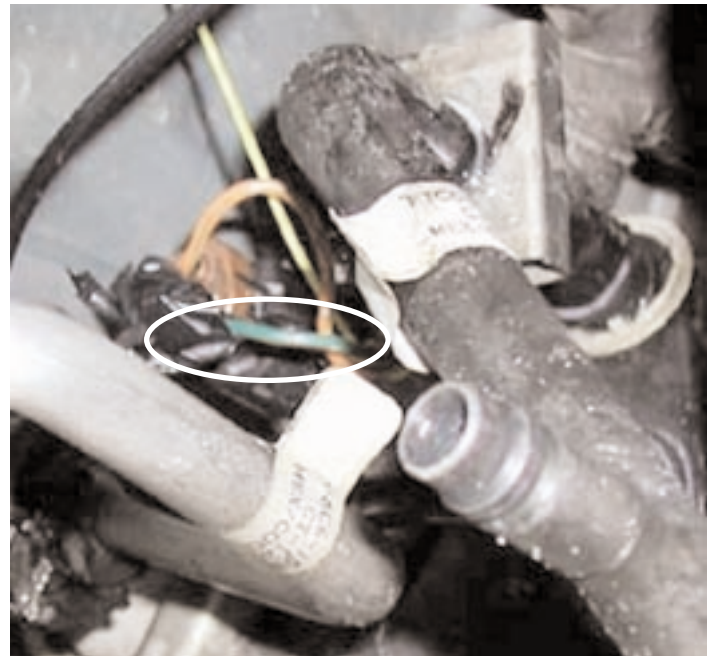
Above: Photo 2. Closeup of taped tap of jumper wire into the "green with red tracer" wire of a '97 Ford Escort (within the ellipse).
